RNAV (GPS) Y RWY 18

PICAYUNE MUNI (MJD)

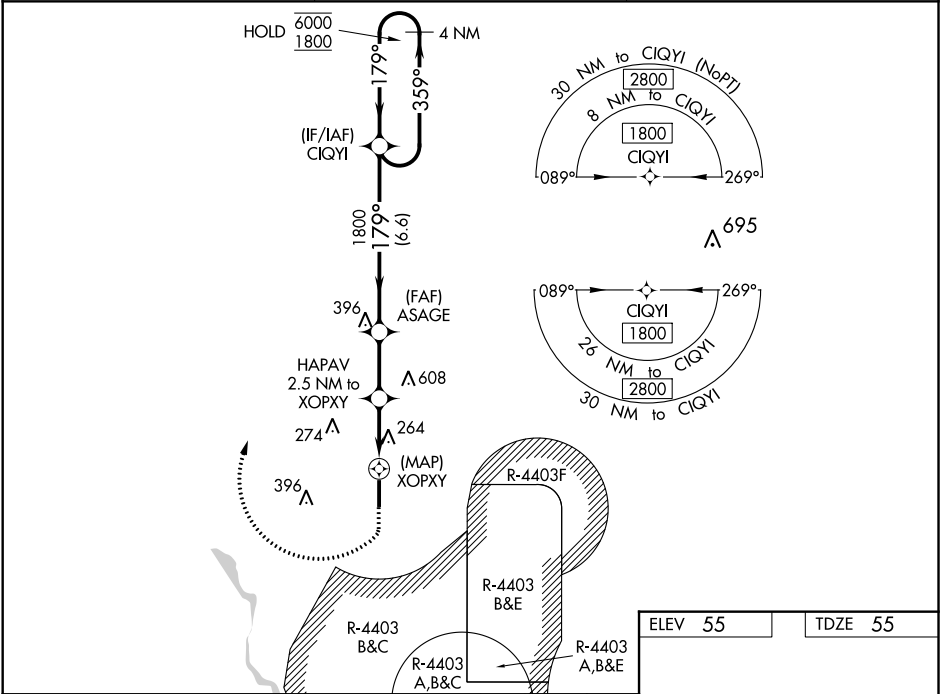
MISSED APPROACH: (Do not exceed 185K) Climb to 560 then climbing right turn to 1800 direct CIQYI and hold.

4 NM Holding Pattern

GP 3.00°

TCH 36
